**CITY OF DAWSON**  
**AGENDA-COMMITTEE OF THE WHOLE MEETING #CW25-06**  
**DATE:** Tuesday June 3, 2025  
**TIME:** 7:00 PM  
**LOCATION:** City of Dawson Council Chambers

### Structural Survey, Diamond Tooth Gerties Condition Assessment

Issue Date:	September 6, 2023	File No.:	2021-2339-25-100
To:	Lorraine Butterworth, Maintenance Manager	Previous Issue Date:	
From:	Richard Annett, C.Eng, P.Eng., MIStructE MICE	Project No.:	2021-2339-25-100
Client:	Klondike Visitors Association		
Project Name:	Structural Survey, Diamond Tooth Gerties		
Subject:	Condition Assessment

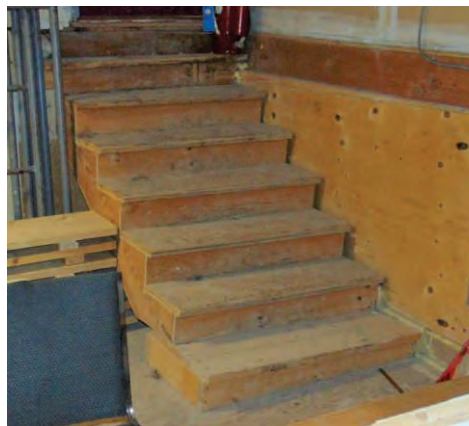
So, if one puts the two snippets of the information above together, there is a possibility the mains water leak melted the permafrost to a much deeper level than normal under the building and this led to the substantial settlement. The short staircase down to the sub-stage basement indicates that the floor has sunk 200 mm, at least, and an extra step has been added at the base. See **Figure 1-1** below. The flooding could have led to fines loss into the granular material as well as compacted it.

**Figure 1-1** Under Staircase, Note Extension at Base

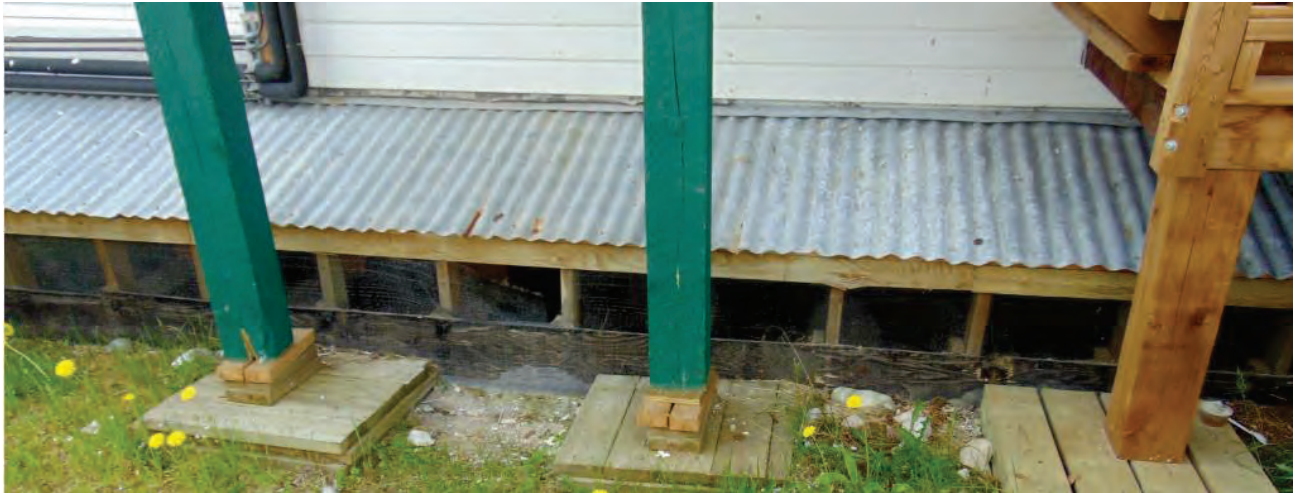
**Figure 2-1** Poor Lateral Support at the Base of Fire Escape Columns

The one fire escape has very poor timber supports balanced on top of space blocks. Refer to **Figure 2-1** on page 4.

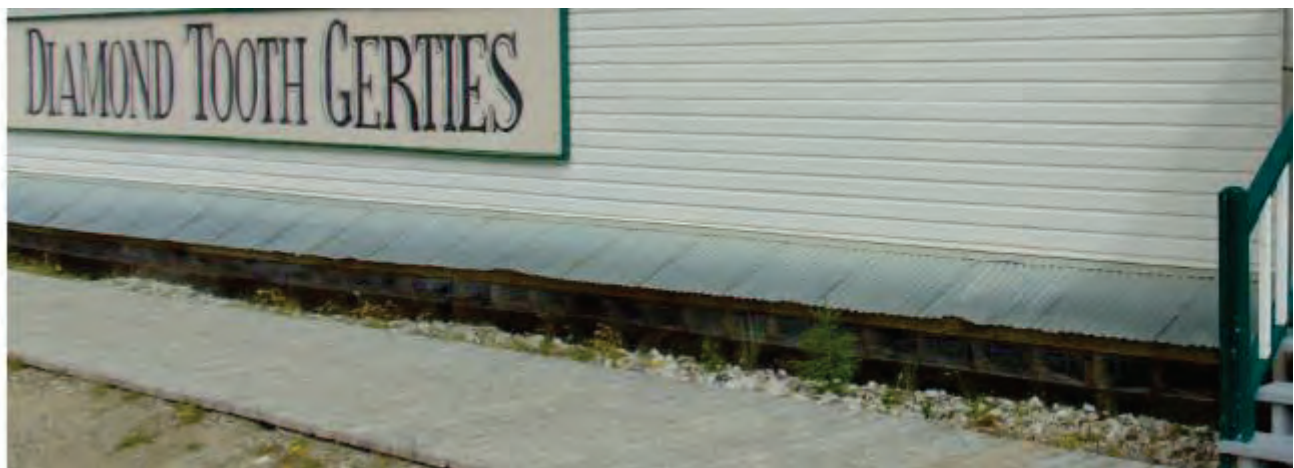
**Figure 2-2** Offset Crawlspace Wall Permitting Large Amount of Air Movement

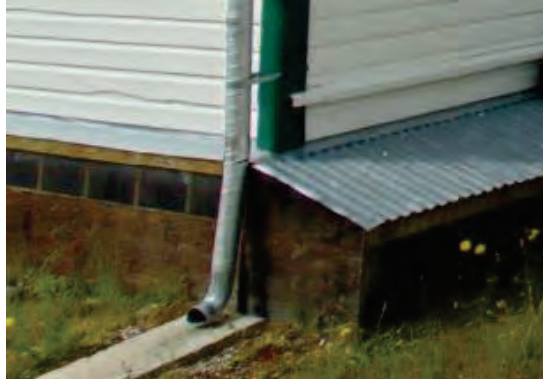
**Figure 2-3** Northeast Corner Showing Downspout

1. Improve the roof drainage; ensure all gutters discharge well into the road.
2. Repair any mesh to the crawlspace ventilation to prevent drifting snow. Go around the periphery and ensure the mesh is clean and secure even if it is not ripped. (General maintenance).
3. Secure the bases to the escape stair posts to prevent accidental or otherwise displacement.
4. Not immediately needed, but it is recommended that reroofing the area above the mechanical room be done. (The area that has rusted and has been patched). General ongoing maintenance.
5. Replace cover strip to east gable with the split in it in order to avoid rain entry. (A very short overhanging roof offers no protection).

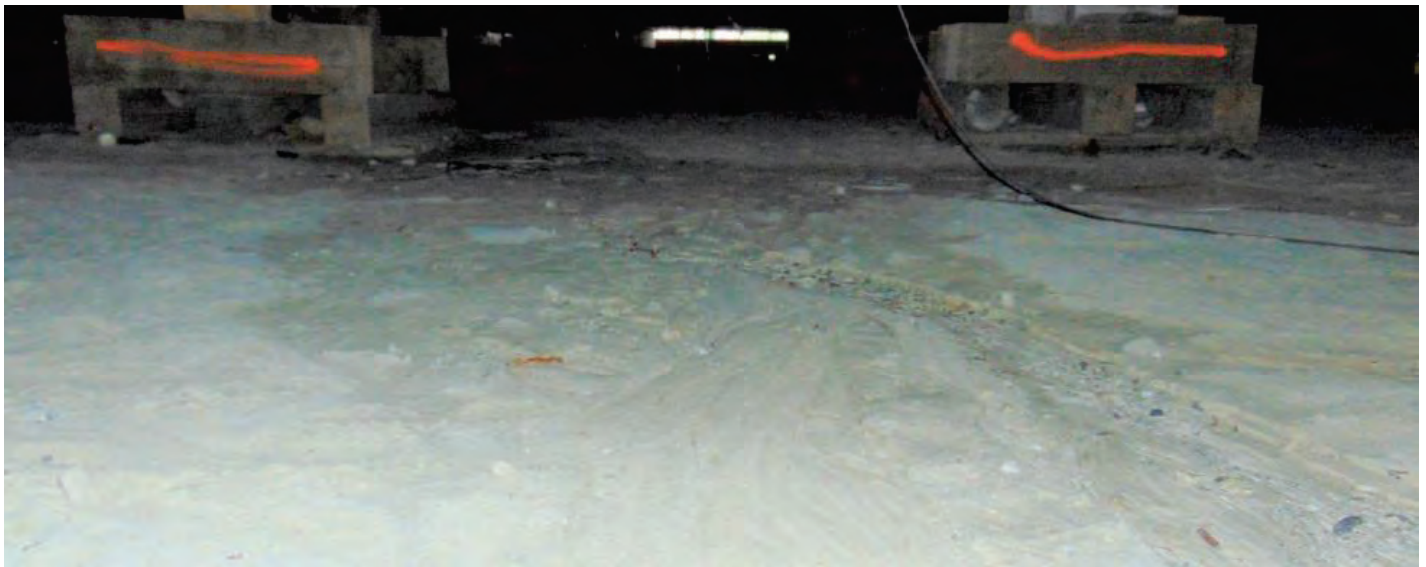
In places, the damaged mesh does not protect against entry to drifting snow. The resistance to melting snow is also a bit suspect. We saw from inside the crawlspace that small rivulets indicate the presence of quite a bit of water in the melt leading to saturated surfaces around bases.

**Figure 2-4** Crawlspace Surface Showing Meltwater Running Towards Northeast

There are signs that melt water or rainwater is getting into the crawlspace and running across the crawlspace floor from southwest to northeast direction. The ground is covered in what appears at the surface to be silt or fine sand and has likely filled the voids of the granular material placed under the building when the ground was improved. (See Wood and Associates reports). The new bases were built off the fine-grained soils as confirmed by the client where a 300 mm thick layer has been observed. However, it is unknown how well the material under the building was compacted and whether the water main flooding caused a loss of fines, (that could cause settlement), which is still being 'felt' by the building. Another possibility is that there was a lens of ice-rich ground beneath and the flood managed to melt it or a former river channel with coarse material is permitting groundwater to remove fines. For certain, the building is still settling.

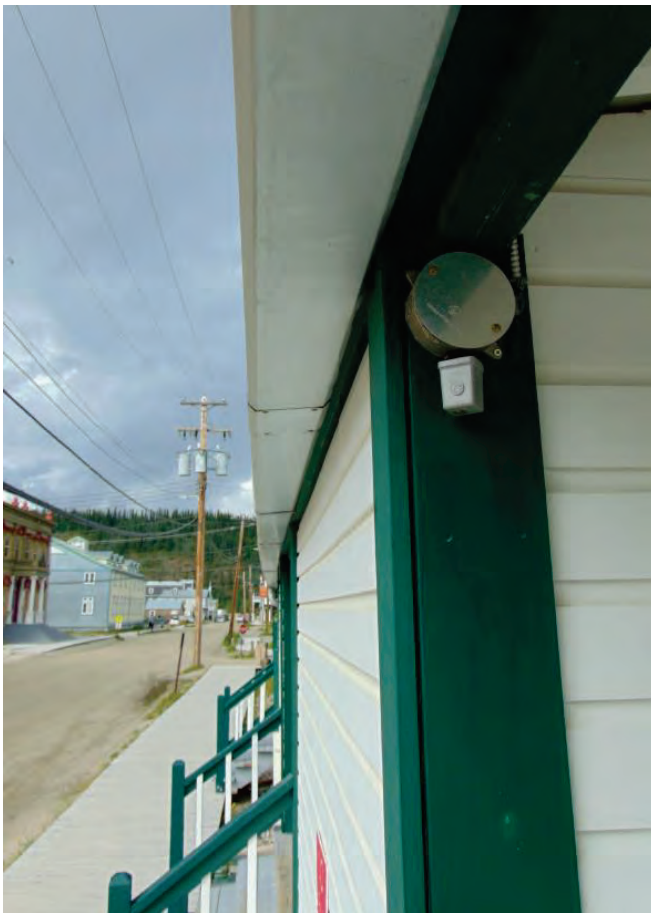
The rebuilt south elevation indicated bowing in plan as seen from the guttering and façade in the photo below. On the inside of the building, this is further highlighted by gaps between the internal wall and the eaves wall. The extent of the bowing on the outside appears to be a lot more than that seen on the inside. This could be due to some racking at the head of the internal walls.

**Figure 2-5 Bow in South Elevation**

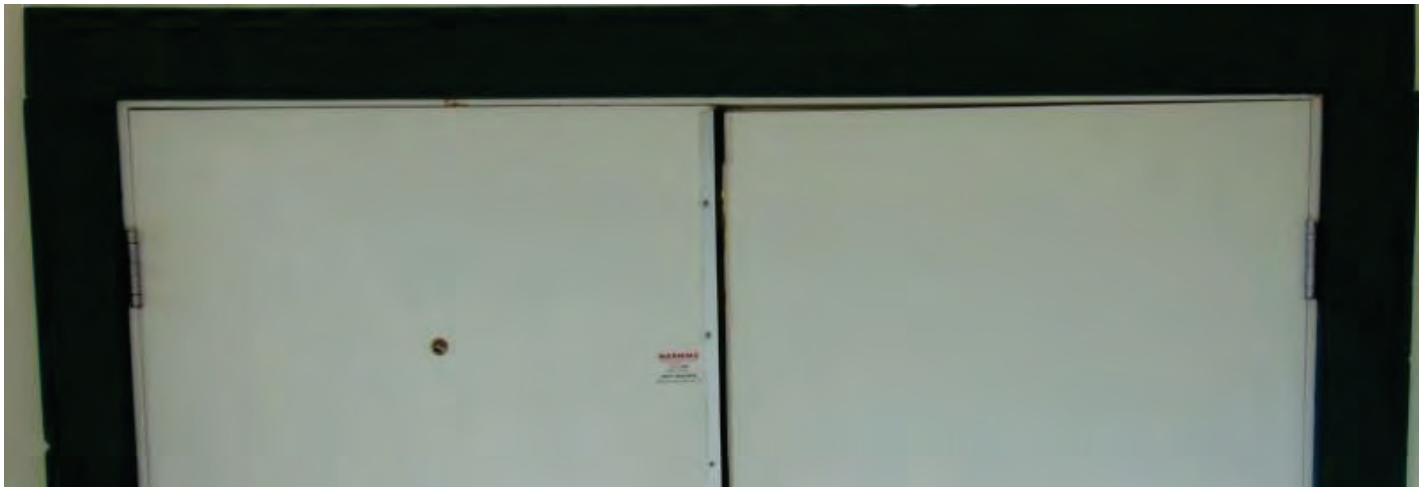
The gable end of the Main “Hall” appears in reasonable condition. The balcony to the façade is sagging and the roof needed reshingling, but is now complete. The west gable to the southern lean-to part of the building, whilst looking in reasonable condition, appears to show settlement, if you look at how the main doors have moved.

**Figure 2-9 West Wall Movement Indicated by Gaps Around Doors**

Judging from this movement over a 900 mm width, it would appear the south end of the gable wall has gone down 30 to 40 mm.

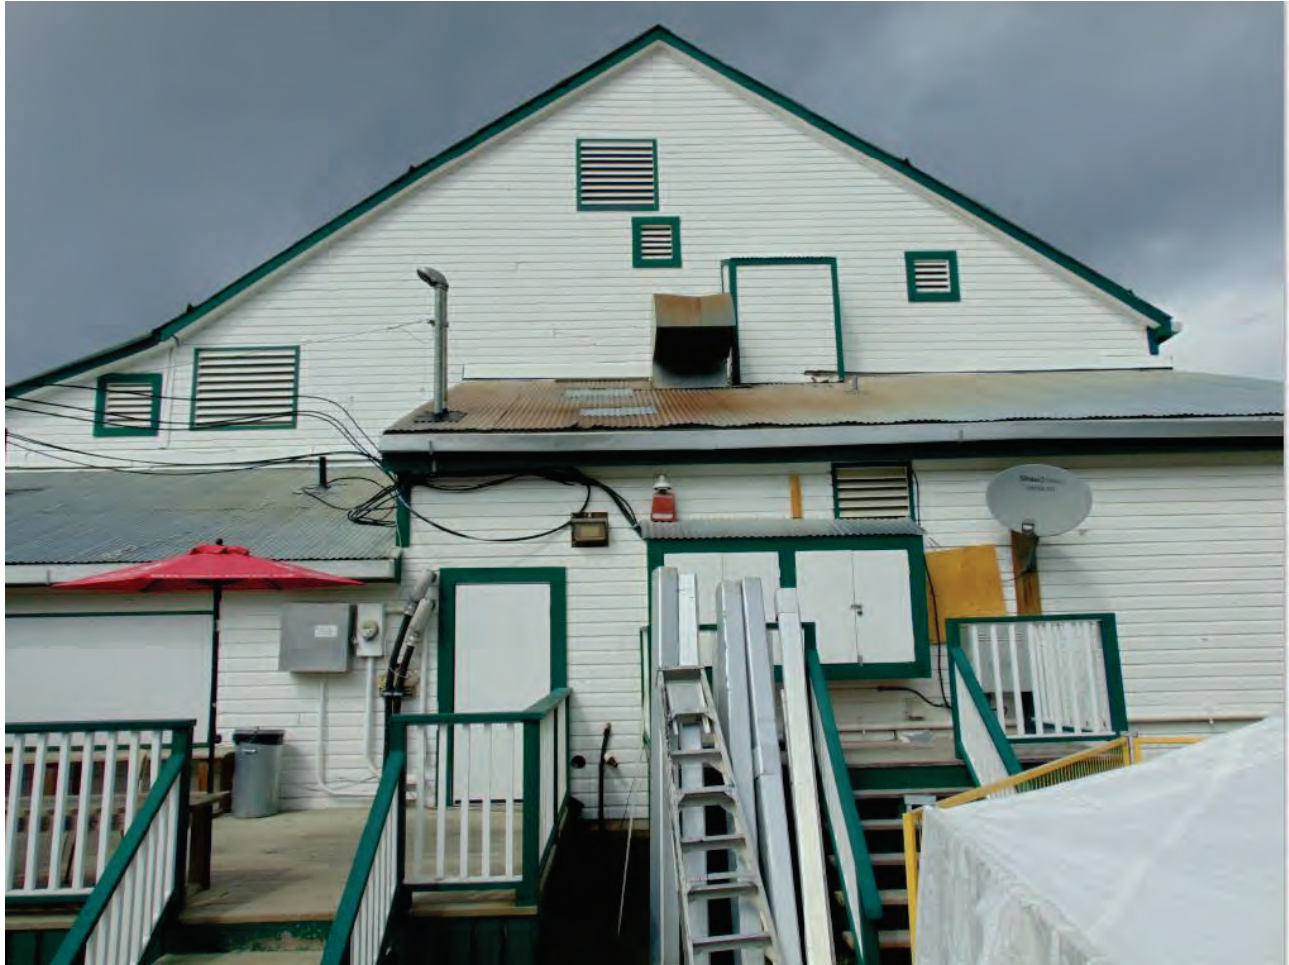
Figure 2-10 East Elevation

The east elevation is a mix between the gable end of the Main “Hall”, the back of the stage and the east wall to the lean-to single-storey extension built in the 80s. There is also a deck area as seen in the photo below. Overall, the façade looks in reasonable condition.

The roof covering of the boiler room shows characteristic early-age rusting due to sulphurs in the oil. A couple of roofing patches are readily seen to the left of the flue where revisions in the boiler room have been made in the past that necessitated roof openings being abandoned.

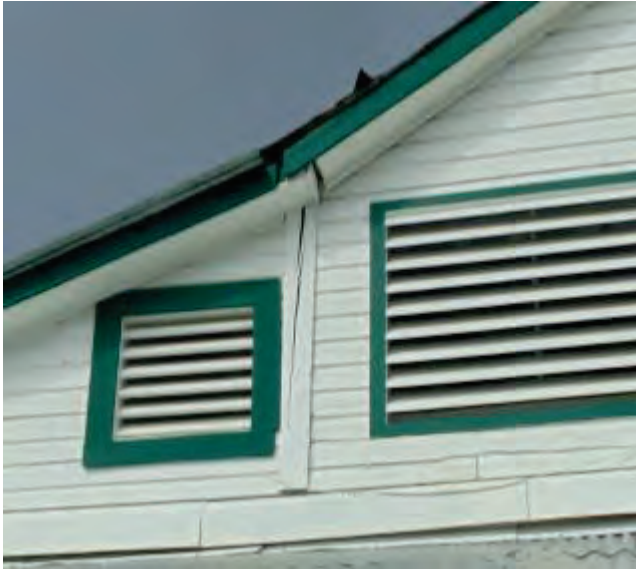
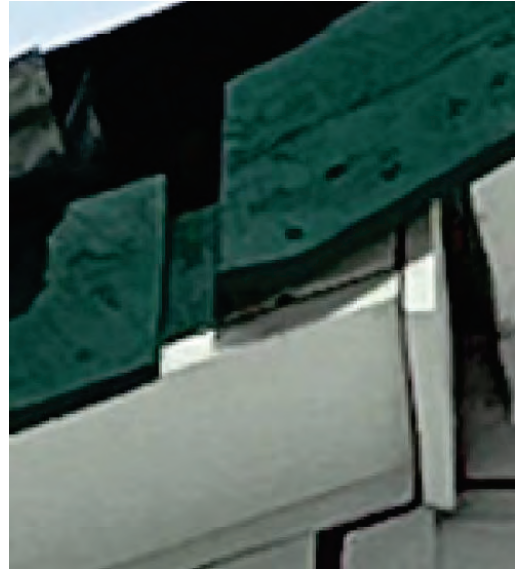
At the junction of the southern lean-to gable and the Main “Hall,” there is a large vertical separation crack. (top left of the photo above and shown in the photo below). The movement is approximately 25 mm.

The movement of this south extension has been discussed above. It looks like this gable has rotated and the south wall has settled as a result, the roof trusses have rotated and the top chord pulled away from the building at the top. If one looks closely at the crack, someone painted the backing timber green too. No movement has happened since that time. So, this could be a relic of the previous settlement which was stubborn enough not to self-close even if the building had been releveled. See **Figure 2-11**.

**Figure 2-11 Two Photos of Separation between South Lean-to and Main "Hall"**

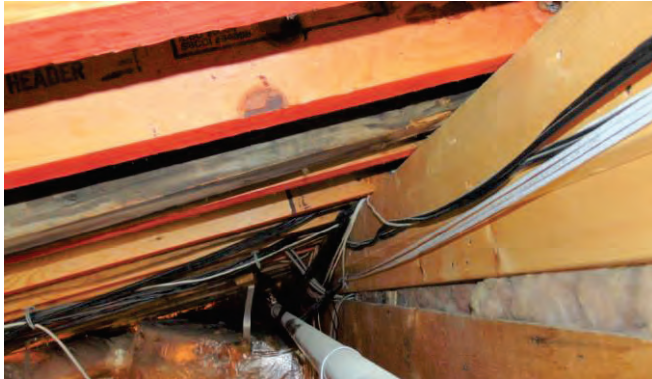
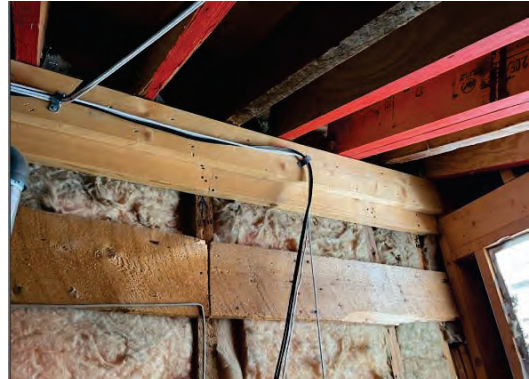
Figure 2-12 Lean-to-Roof Connection with the Main "Hall"

If one looks at the old drawings, one can see that a truss frame was used, (and was meant to be retained), but the left diagonal brace did not appear to be present. The vertical brace at the left support was not present either and the top chord was found bearing on a wall plate supported off the original studs supporting the main roof. In the photo above this wall plate is clearly seen and when the LVLs were installed new bearing plates were added and doubled up to improve on the bearing area. The arrangement does not make for very good bearing and the ability to tie the rafters in laterally is poor given the building's propensity for moving. Hence, it is considered, the detachment seen in the photos below of the hold down twist traps to the LVLs. But also, with snow loads, the rafters would sag some and also put a pull on the upper support. So this might also contribute to the state of the tie downs.

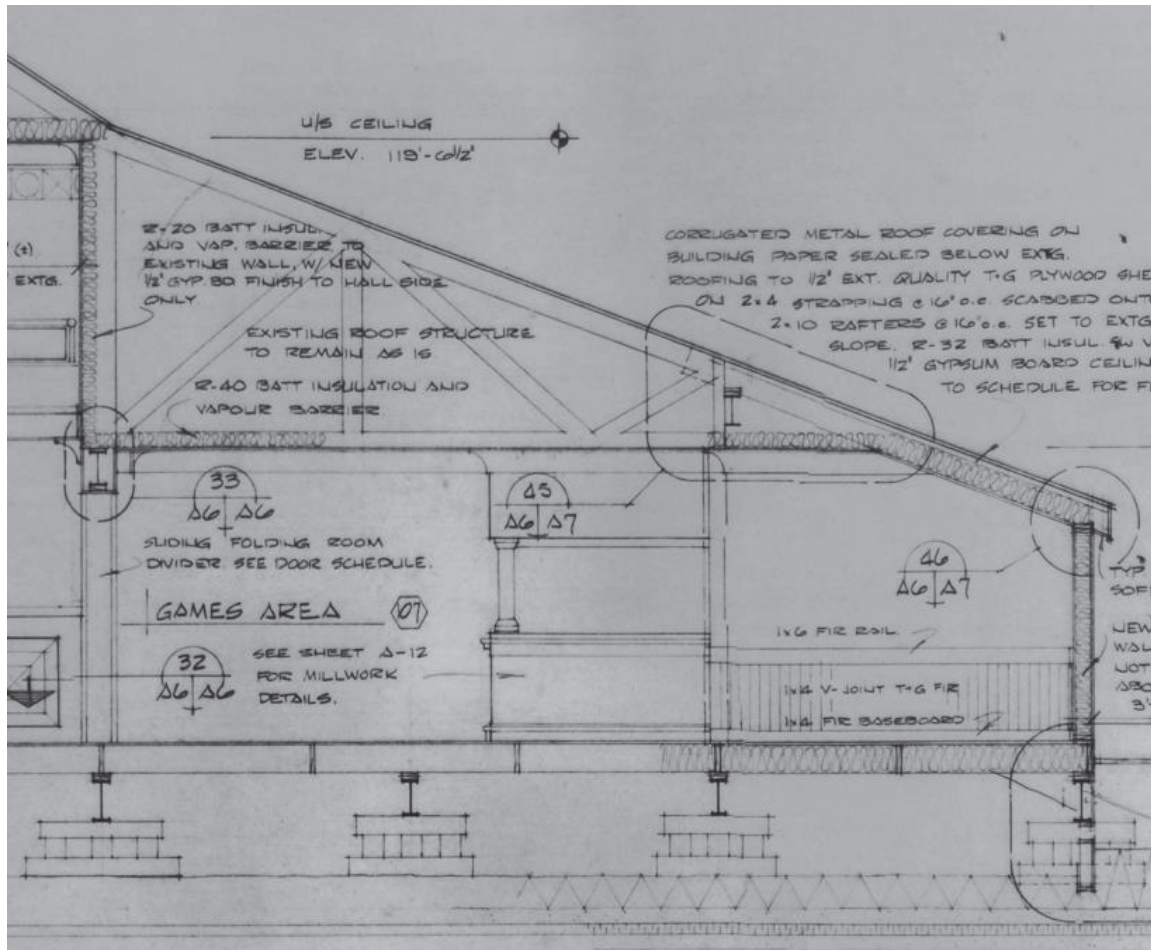
Figure 2-13 Roof Details of Lean-to Roof

Our inspection did not reveal the steel beams shown supporting the lower eaves with the top truss chord extended down to the top of the lower wall with a splice rafter. The roof had quite a bit of insulation over the ceiling joists. We do not know if the LVLs simply sat on the steel beam at the lower eaves level or continued over it and were supported additionally off the south wall.

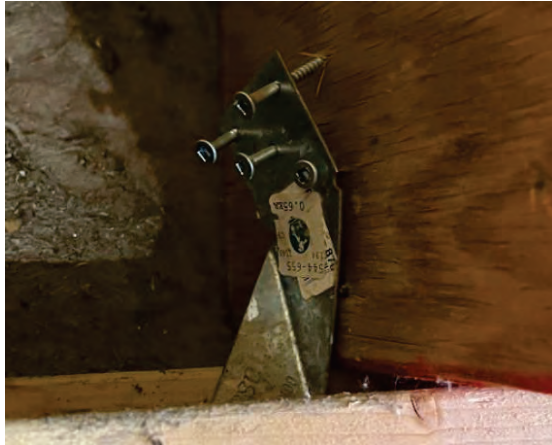
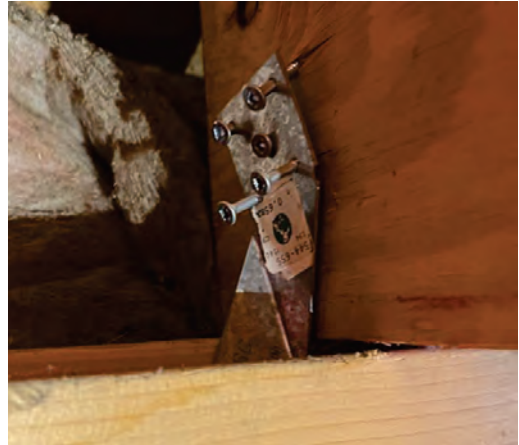
**Figure 2-14 Rafter Cleat Pull Outs**

The above does reveal what is likely to be happening to the wall on the right, which is the south wall on Queen Street. If the support on the left drops, due to settlement, it is likely to push out the wall on the right as the length of the top chord of the truss stays the same. This is what is seen to be happening, based on the level survey.

If the building keeps moving, it is difficult to recommend an appropriate cleat to the LVLs in the roof space. Whatever is there will be subject to ongoing pull-push forces that are likely to destroy them. We do not want to suggest such a robust fitting that the rafters pull and push the wall studs around with them as they are supporting the main roof. If we leave the studs alone and the wall plate that supports the rafters, then that is the best route forward.

For now, it is recommended that small truss clips be used to secure the rafters, such as a Mitek RT4. To keep the plate restrained from push/pull forces from the LVLs, it is recommended that a twist strap RT7A is nailed between the studs and the top of the plate. That would mean the existing wall plate fixings can be better relied upon to simply support the LVLs vertically.

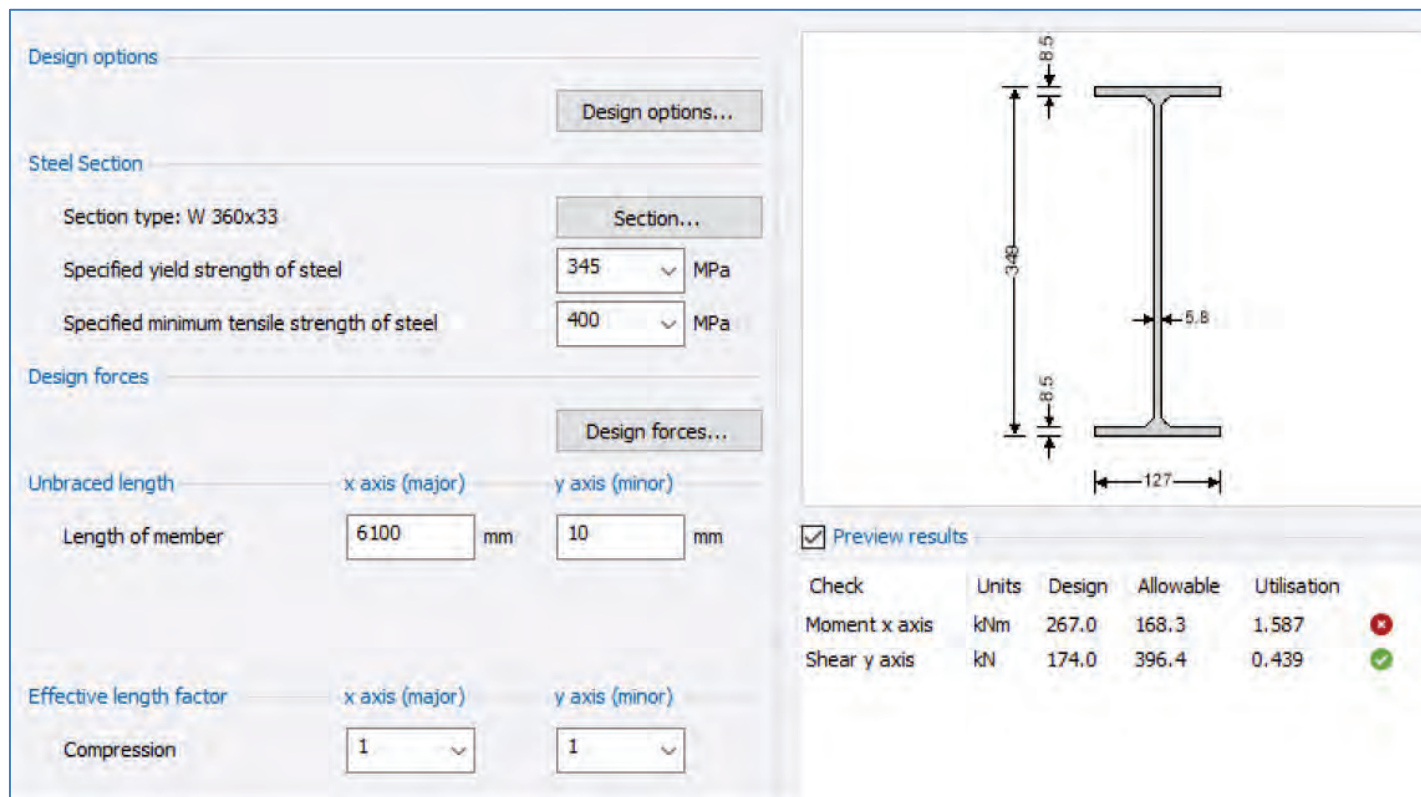
Figure 2-15 Beam Retro Design Showing Moment Capacity Exceeded

So from a current code compliance, the beam is over-stressed by 150%

Perhaps the best route forward is to confirm the beam sized used is the same as that marked on the drawings and plan for a replacement or augmentation, whereby we add a new frame within the existing one and try to increase the robustness. This will narrow and drop the openings by the depth of the new frame. That might be undesirable and would leave one with only a replacement option. It is recommended some further work to be done on upgrading these beams, now that we have shown the beams to be deficient.

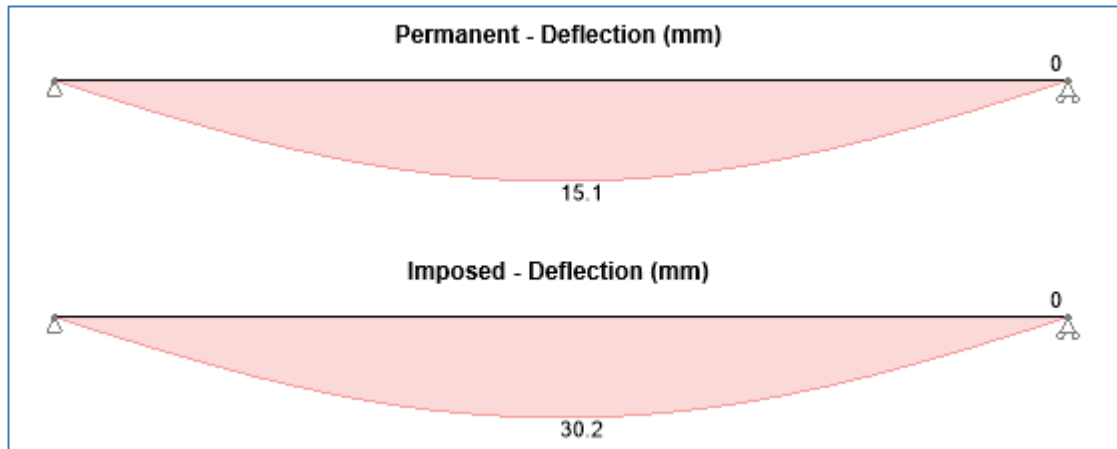
**Figure 2-16 Beam Deflections Under Dead and Live Loads**

Total deflection; 45 mm at SLS.

The limit for deflection is span/360 for live load deflection; This would be  $6,100 \text{ mm} / 360 = 17 \text{ mm}$ . From the analysis, the snow load deflection is ~ 2 times the limit.

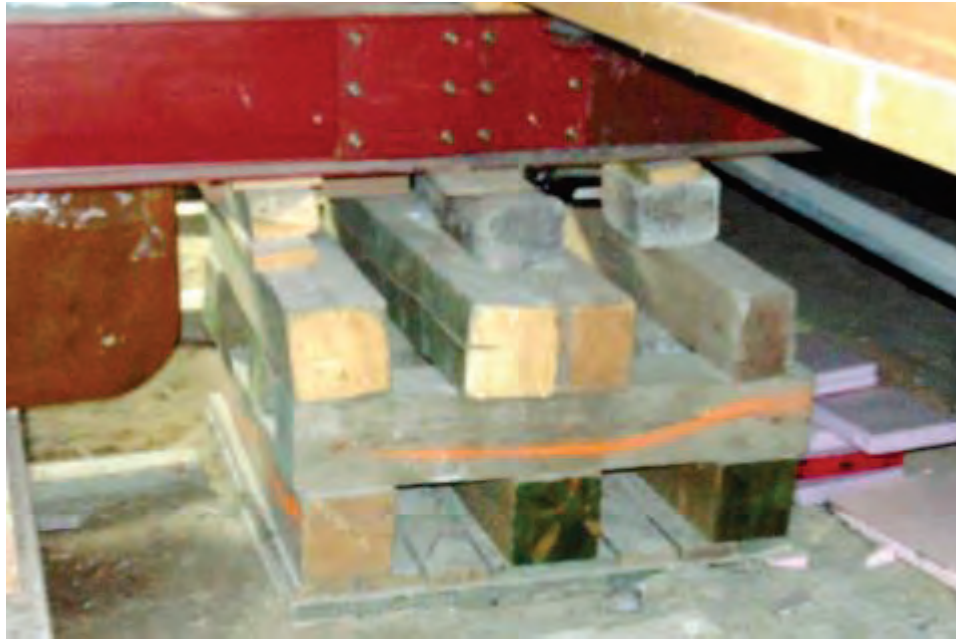
The cribbing and bases under the building appear in reasonable condition. Previous floor jacking has left shims of ply and wood that are not treated. Some are not secured. A typical example is shown below.

**Figure 2-17      Typical Cribbing Showing Shims Under Steel Beams**

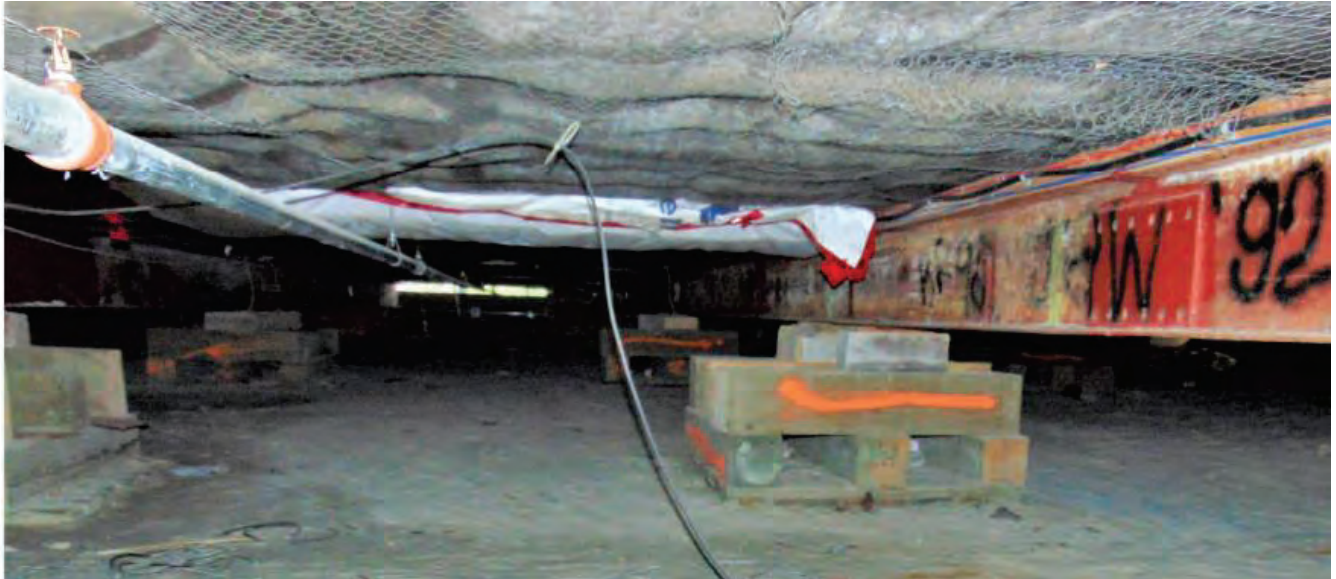
None of the steel beams sitting on the cribbing have any compression flange lateral support, as can be seen in the photo below. Thus, if the building got hit by a quake or vehicle from the north-south direction, it may well be possible to push the building over in the north-south direction quite easily. From the height of the beams and the width of the cribbing, this would mean the main floor would end up sitting on the dirt of the crawlspace.

**Figure 2-18 Steel Beams without Lateral Support at Support Locations**

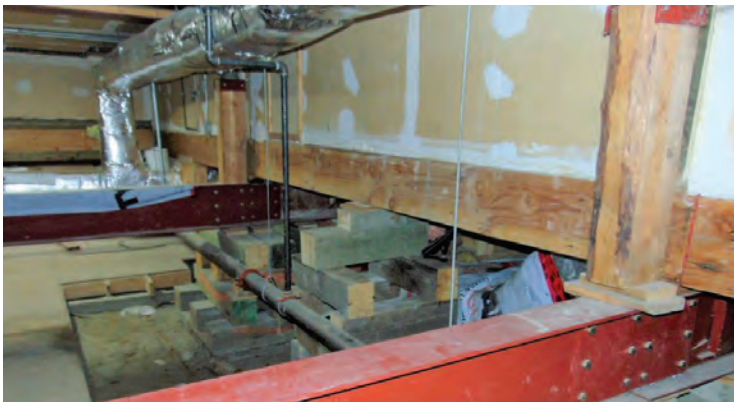
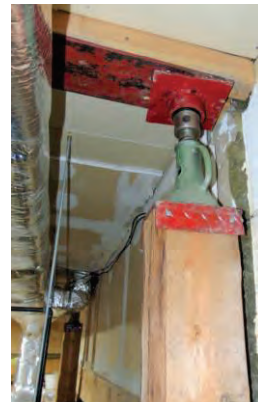
Also of concern are the props that support the beams to the main stage in the Main “Hall”. The top of the jack is unsecured and the base of the timber posts are in a similar state. So long as the back wall of the stage is a shear wall, which it should be, being the gable end of the original building, then the system should have global stability. But since the room is being occupied for storage, is inconceivable that something could accidentally hit one of these.

**Figure 2-19 Props to Back of Stage as Seen from Basement**

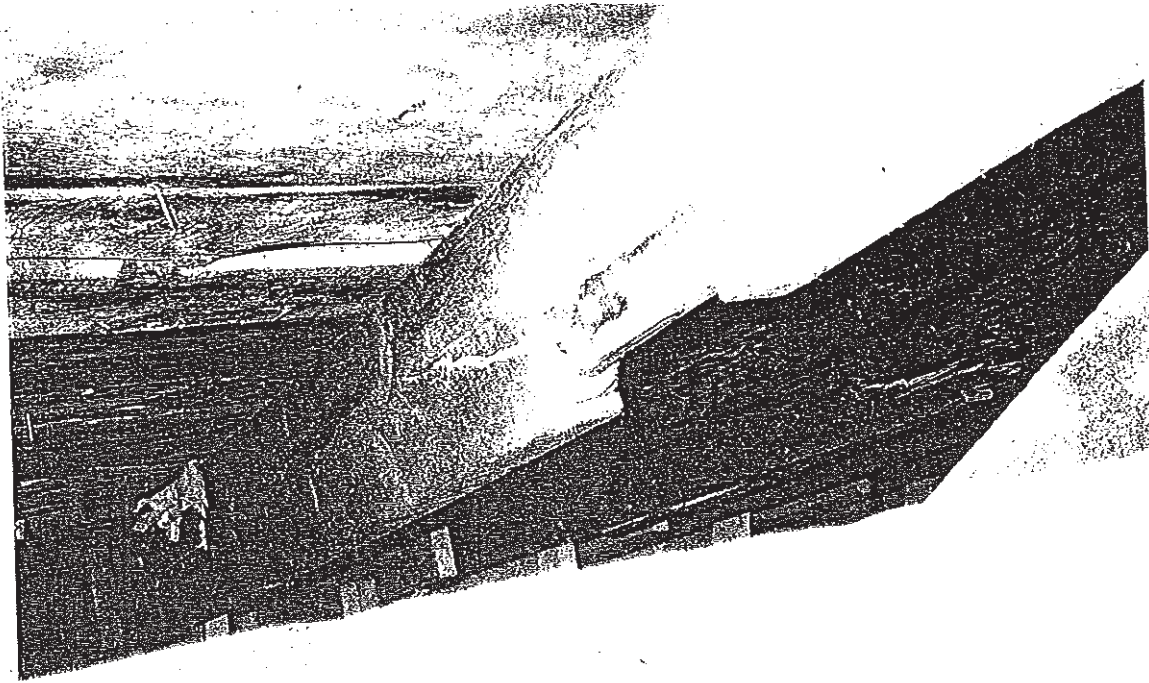
CRACKED RAFTER (SOUTH SIDE)

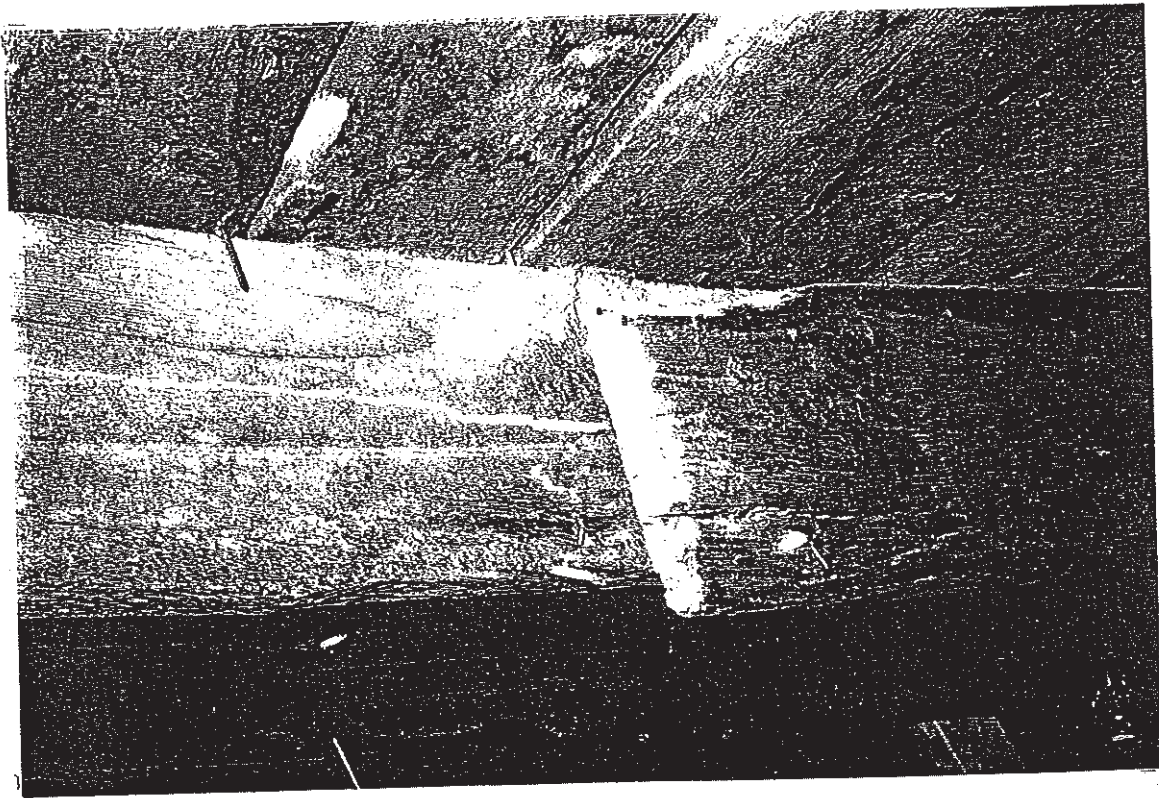
CRACKED RAFTER AT SPLICE (SOUTH SIDE)

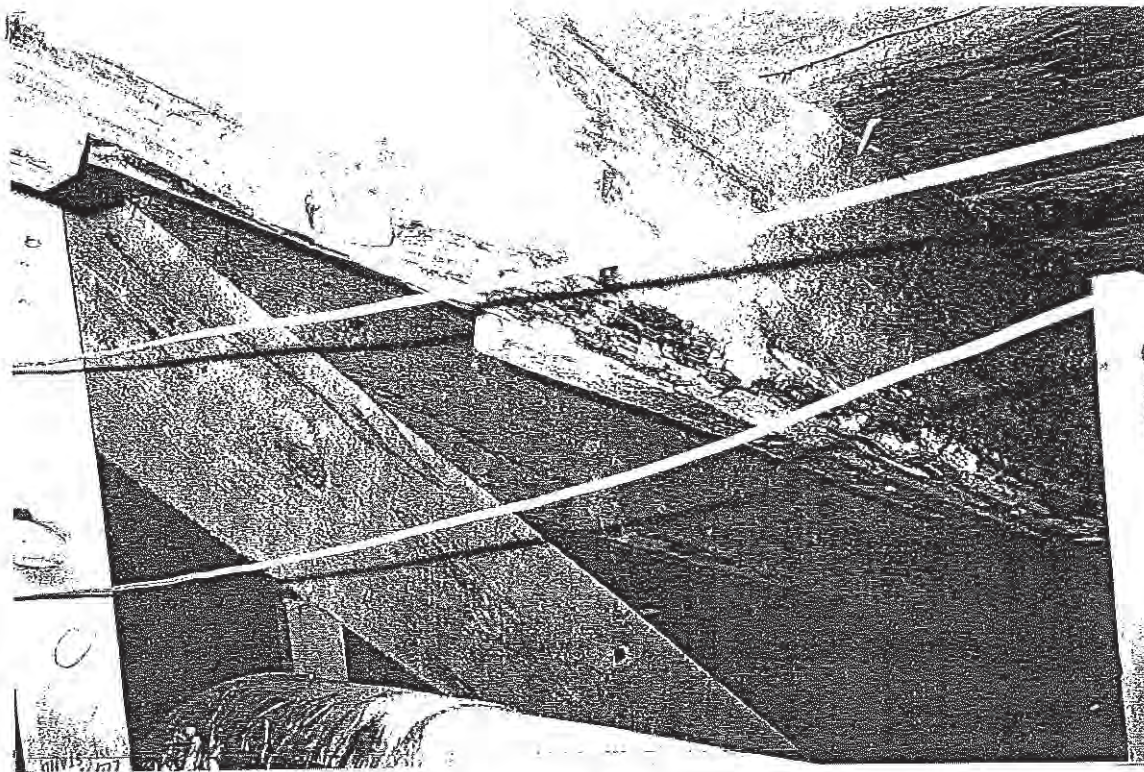
ROTTED RAFTER (SOUTH SIDE)

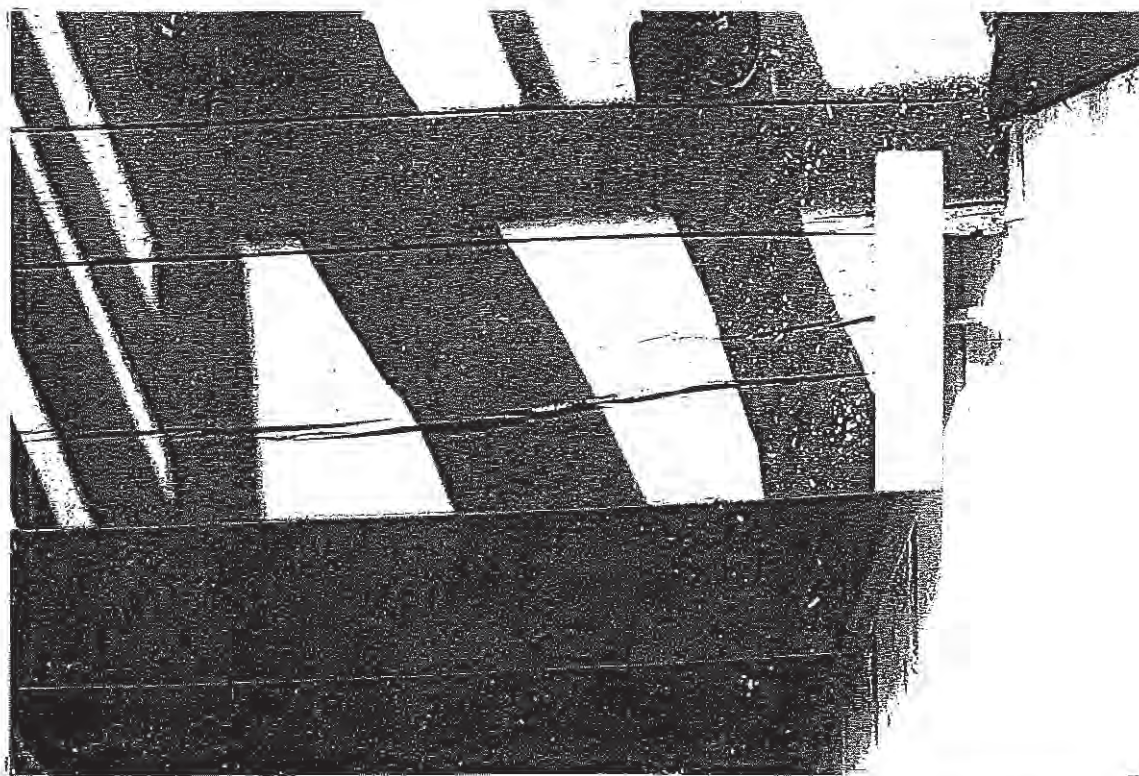
CRACKED STAIR TREAD (northwest building corner)

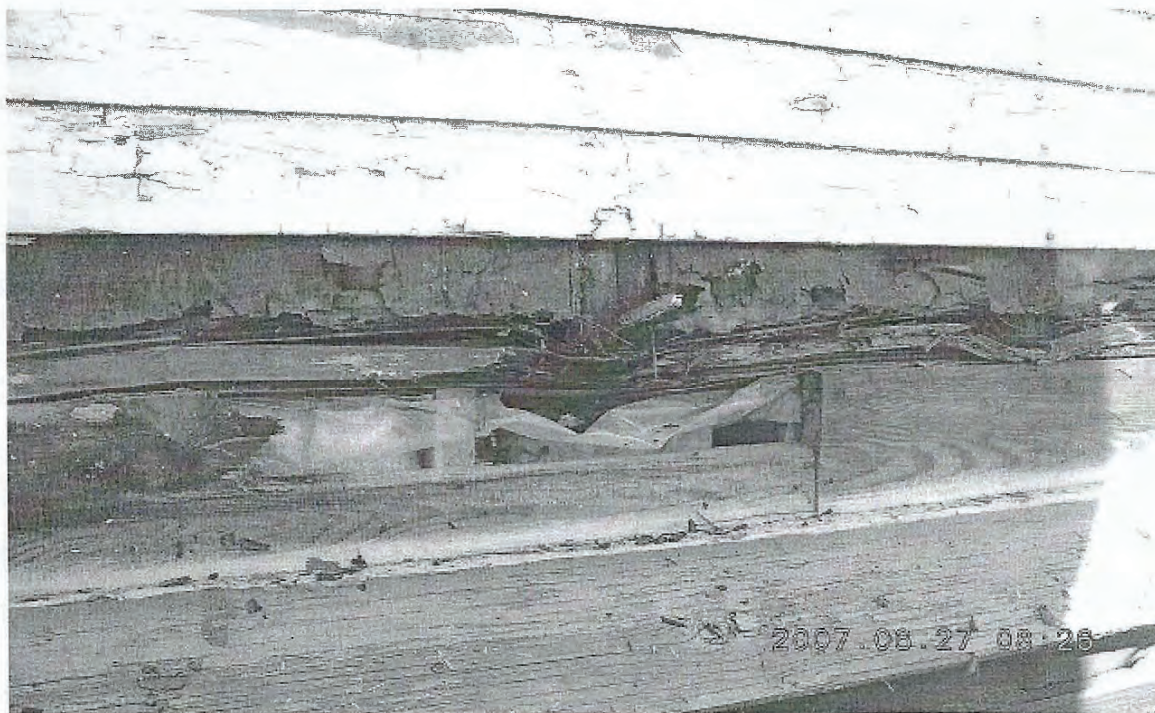
The exterior siding was removed at the bottom of the wall in order to facilitate an inspection at this location. Extensive rot was found to exist at the bottom plate and lower stud area at several locations. This rot was likely due to moisture accessing the stud cavity at the top of the wall and saturating the bottom plate/ lower wall stud over a number of years.

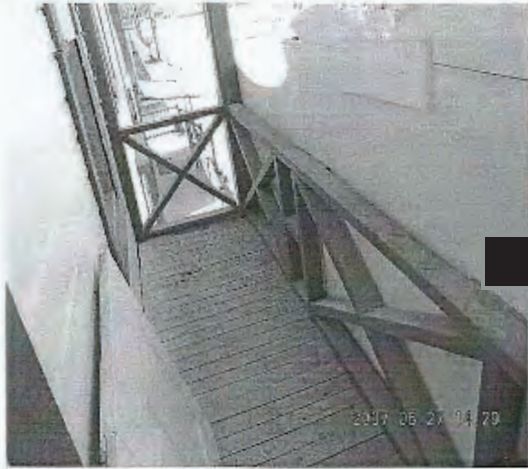
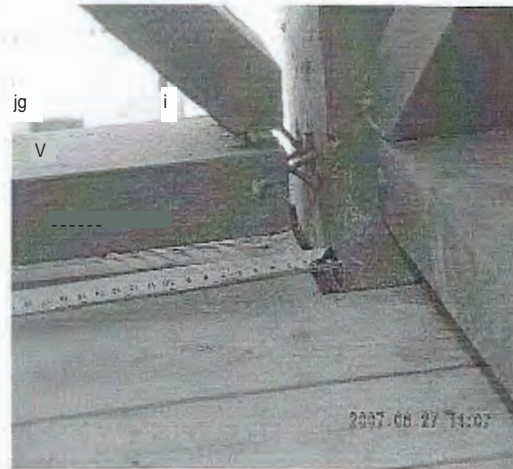
This balcony has not been accessible since the 1982 renovation and possibly prior to that. However, it is evident that this element has sagged over time as evidenced by the separation shown at the bottom of the guardrail location on the following photos.
